# ***SUPPLEMENTAL GEOPHYSICAL AND GEOTECHNICAL DATA DAUPHIN ISLAND EAST END BEACH AND DUNE RESTORATION PROJECT***

Project No. 631019097

**March 1, 2022**  
*(Final)*

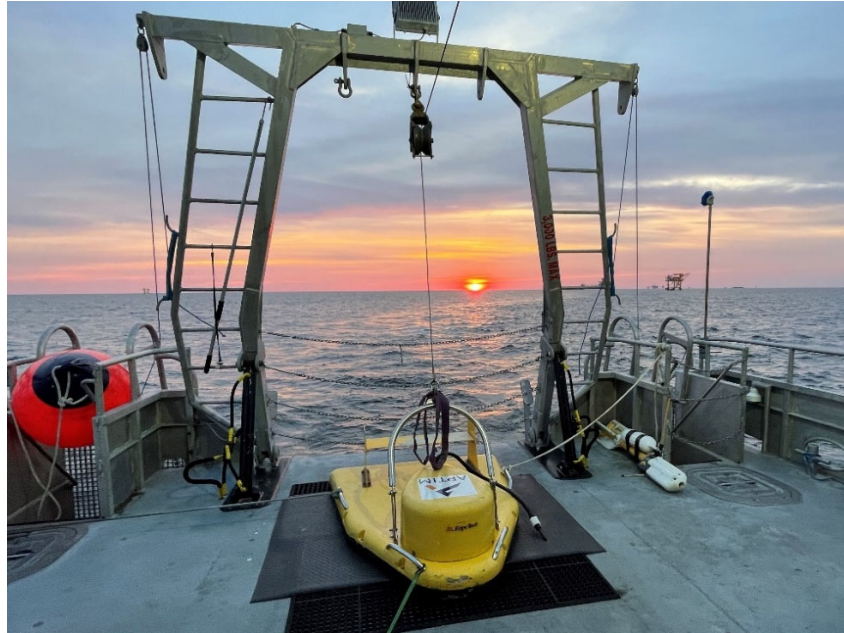
**Figure 6. Edgetech 512i on the deck of R/V *Apalachee*.**

frequency energy at all pulse settings, which allows deeper penetration of seafloor sediments, while at the same time maintaining the high resolution of the original configuration.

In order to minimize noise related to the survey vessel and sea conditions, the seismic towfish (which operates as both the source and receiver for the sub-bottom system) was deployed and towed behind the research vessel. The sub-bottom system was interfaced with RTK via Hypack 2020® navigational software. The location of the fish tow point (as referenced to the vessel center of mass), together with the length of cable deployed from the tow point, were entered into Hypack 2020® in order to account for the fish layback and provide accurate positioning of the seismic fish during the survey. The sub-bottom system was operated by the Discover-SB® software program. At the start of the sub-bottom profiling survey, the sweep frequencies of the outgoing pulse together with the different gain settings available within Discover-SB® were adjusted to obtain the best possible resolution for the survey. The data was continuously bottom-tracked to allow for the application of real-time gain functions in order to have an optimal in-the-field view of the data. Automatic gain control (AGC) was used to normalize the data by strengthening quiet regions/soft returns while simultaneously reducing/eliminating overly strong returns by obtaining a local average at a given point. A time-varying gain (TVG) was used to increase the returning signal over time in order to reduce the effects of signal attenuation.

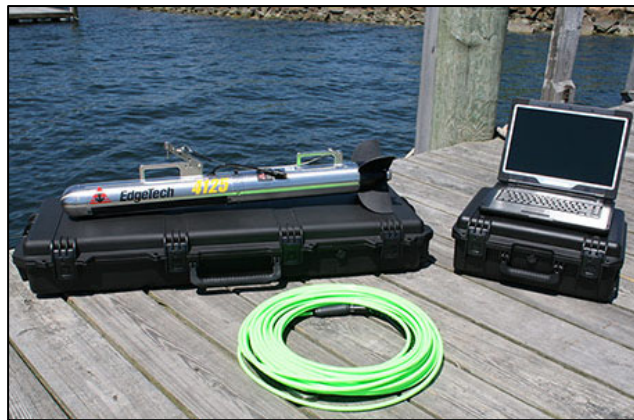
**Figure 7. EdgeTech 4125 sidescan sonar system.**

During this sand search investigation an EdgeTech 4125 sidescan sonar system was used (Figure 7). The EdgeTech 4125 sidescan sonar systems uses full-spectrum chirp technology to deliver wide-band, high-energy pulses coupled with high resolution and good signal to noise ratio echo data. The sonar package included a portable configuration with a laptop computer running EdgeTech's Discover® acquisition software and dual frequency towfish running in high definition mode. The sidescan sonar data were merged with positioning data from RTK satellite navigation system via Hypack, video displayed, and recorded to the acquisition computer's hard disk for post processing and/or replay. All sidescan sonar data were collected in the default EdgeTech JSF file format. An EdgeTech 4125 multi-purpose sidescan sonar system consisted of a dual frequency towfish operating at 600/1600 kHz, with maximum range scales of 394 ft (120 m) to either side of the towfish (600 kHz) and 115 ft (35 m) to either side of the towfish (1600 kHz) was used for the survey area. These range scales are the maximum manufacturer recommended ranges for the frequencies listed above. However, geophysicists in the field based the recorded ranges on the field conditions and may not have utilized the maximum range scales.

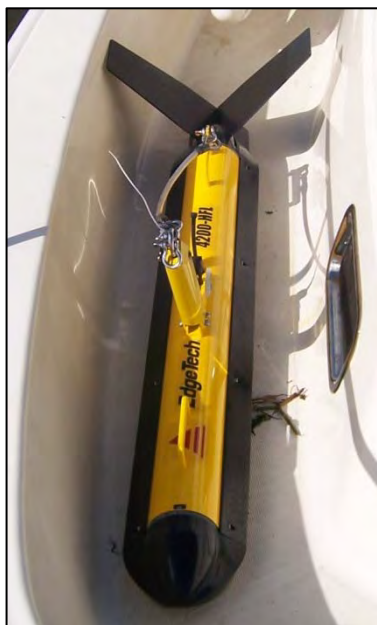
Figure 12. EdgeTech 4200-HFL sidescan sonar system.

During this sand search investigation an EdgeTech 4200-HFL sidescan sonar system was used (Figure 12). This system uses full-spectrum chirp technology to deliver wide-band, high-energy pulses coupled with high resolution and good signal to noise ratio echo data. The sonar package included a portable configuration with a laptop computer running EdgeTech's Discover<sup>®</sup> acquisition software and a 300/600 kHz dual frequency towfish running in high definition mode. Dual frequency provides a more complete sidescan return that aids interpolation at the outer portions of the swath, which in turn provides a more complete data set.

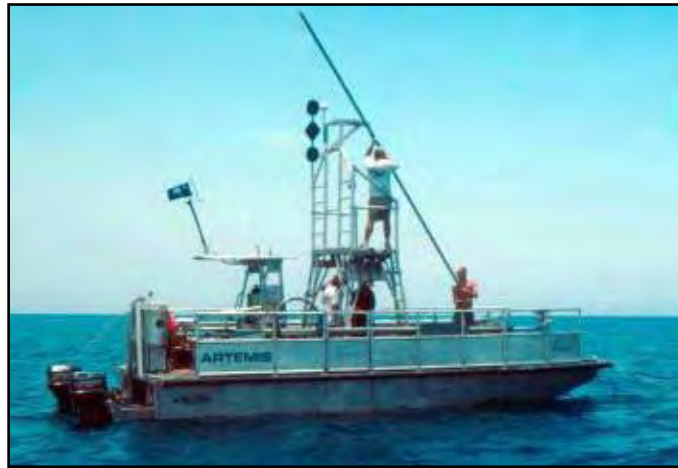
Design level vibracores were collected by Athena Technologies Inc. using Athena's custom designed and built vibracore system deployed from a sampling platform (Figure 14). Athena's system consists of a generator with a mechanical vibrator attached via cable. The vibrator is attached directly to a three-inch diameter, galvanized sample barrel. The sample barrel is lowered to the seafloor through a moonpool in the deck of the sampling platform by attaching

lengths of drill stem. The vibracore machine is then turned on and the sample barrel is allowed to penetrate until it reaches target depth or refusal.

Figure 14. Athena electric vibracore system.

If recovery was less than 80% of the expected penetration, the pipe was removed, a new pipe inserted, and a jet pump hose was attached just below the vibracore head. The rig was, again, lowered to the bottom and jetted into the sediment just above refusal depth. The jet was then turned off and the vibrator resumed collecting the lower part of the core.

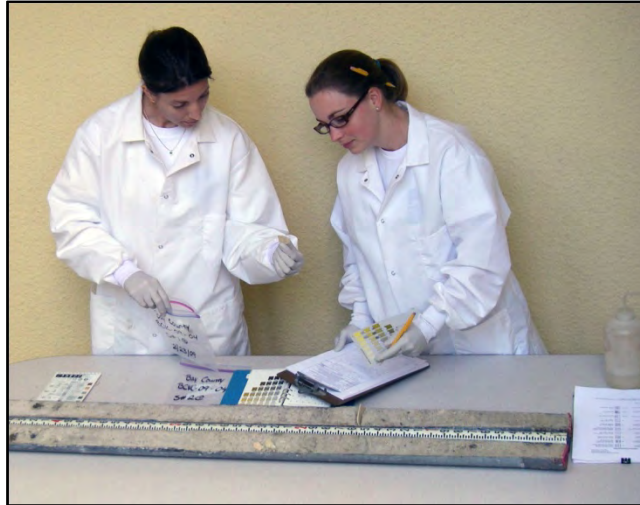
Figure 15. Vibracore logging, sub-sample collection and Munsell color determination being conducted at CPE's office in Boca Raton, Florida.

Upon removal of the vibracores, they were measured, marked and cut into 5-ft. sections. The cores were then labeled, and transported to CPE's office in Boca Raton, Florida. There, the vibracores were split and logged by describing sedimentary properties by layer in terms of layer thickness, color, texture (grain size), composition and presence of clay, silt, gravel, or shell and any other identifying features (Figure 15). Wet Munsell color was determined in accordance with American Society for Testing and Materials Standard Materials Designation D2488-00 for description and identification of soils (visual-manual procedure) (ASTM, 2009). The vibracores were digitally photographed against an 18% gray background. This is the standard reference value against which all camera light meters are calibrated. Sediment samples were obtained from irregular intervals based on distinct layers in the sediment sequence. The unsampled half of each core was then archived. The top of core elevations were determined from bathymetric survey data.

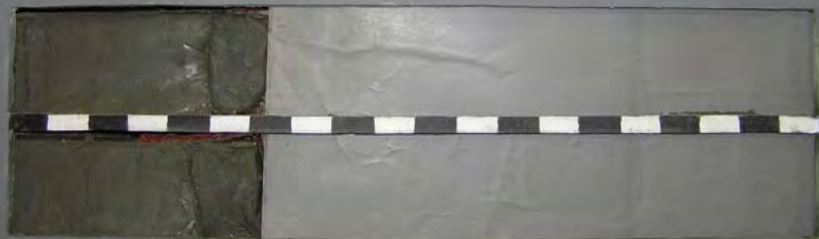
DAUPHIN ISLAND

DIVC-10-02

16.0-16.6

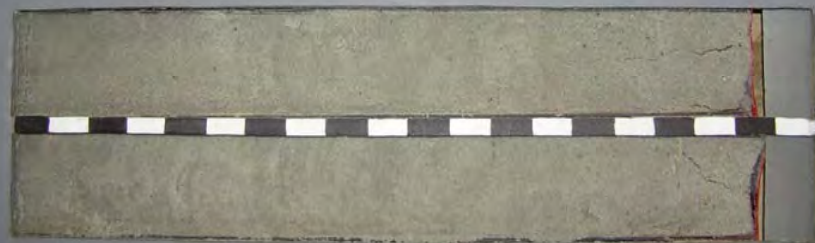
DIVC-10-32

DAUPHIN ISLAND

16.0-17.9

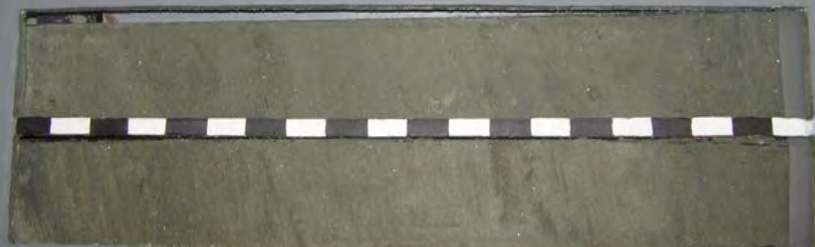
DIVC-10-33

DAUPHIN ISLAND

16.0 -17.9

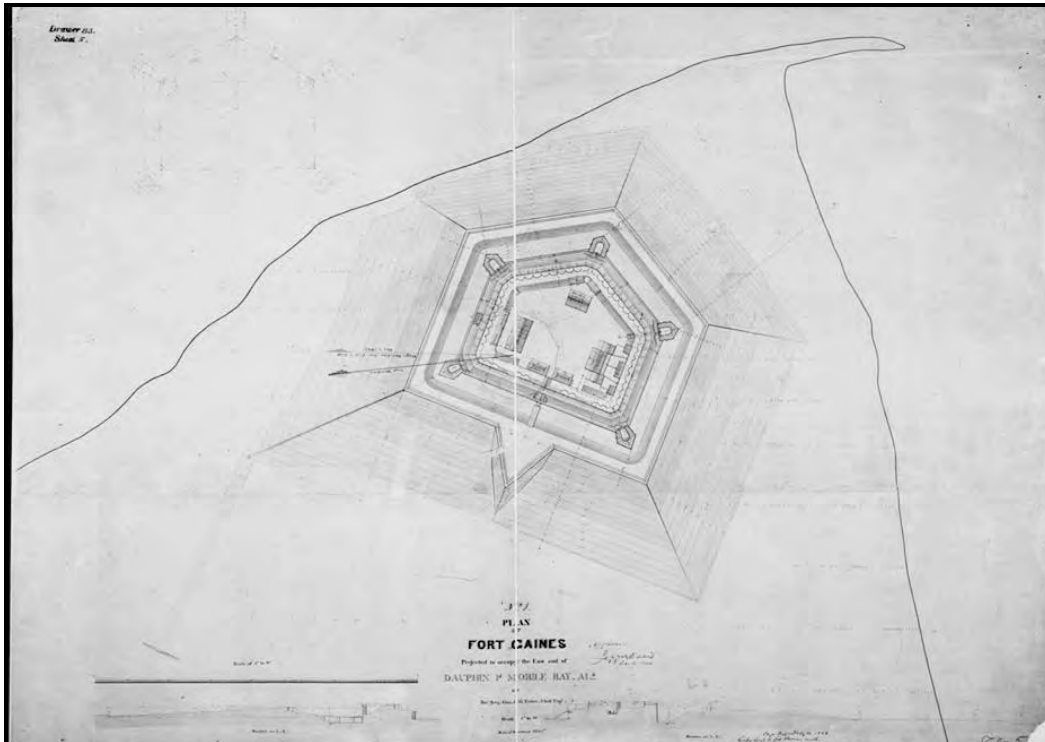
**Figure 5. Plan of Fort Gaines drawn by Brigadier General Joseph G. Totten ca. 1854. (Courtesy Library of Congress).**

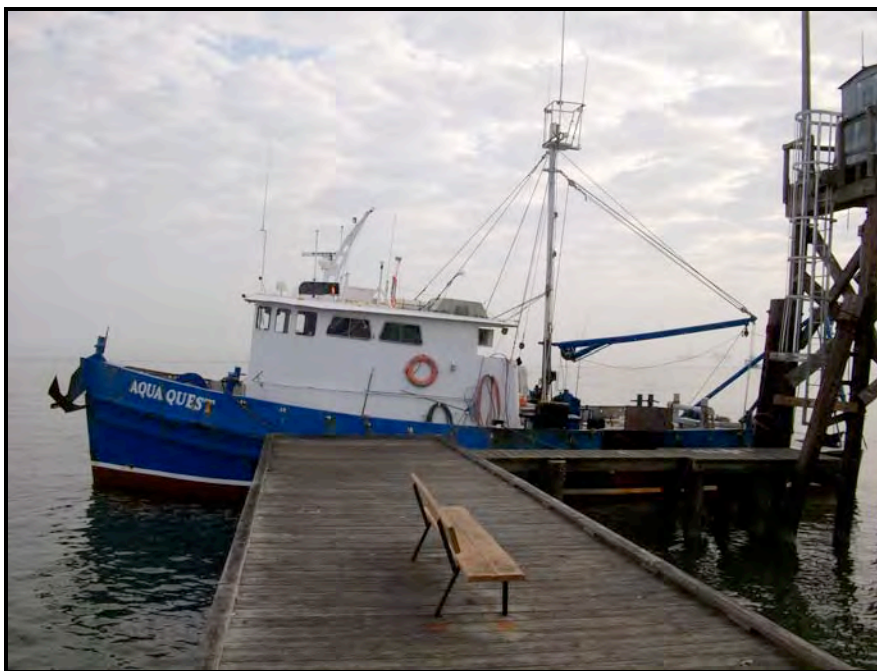
While the survey vessel R/V *Aqua Quest* (Figure 12) was loaded and the remote-sensing equipment rigged, the RTK GPS base station was set up to transmit corrections. Once on site, the speed of sound through water was established and the fathometer calibrated. Magnetometer, side scan sonar and sub-bottom profiler sensors were deployed and the layback of each recorded.

**Figure 12. Project survey vessel R/V *Aqua Quest*.**

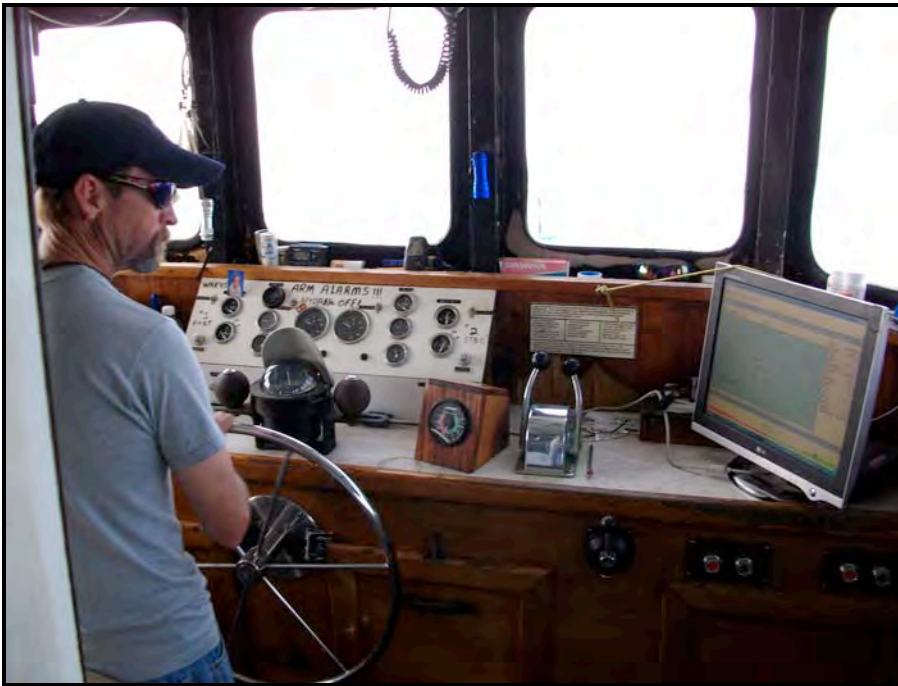
With all equipment running and data quality confirmed, the R/V *Aqua Quest* was systematically navigated down each of the survey lines. Navigation down each survey line was controlled by a computer monitor on the helm that displayed a HYPACK navigation screen (Figure 13). The screen provided the helmsman with a visual projection of the current line, vessel position on line and a right and left of line indicator. Vessel speed was maintained at approximately four knots. Operators continuously monitored the magnetometer, side scan sonar and sub-bottom profiler computers to identify anomalies and maintain

**Figure 13. Computer navigation system located at the research vessel helm.**

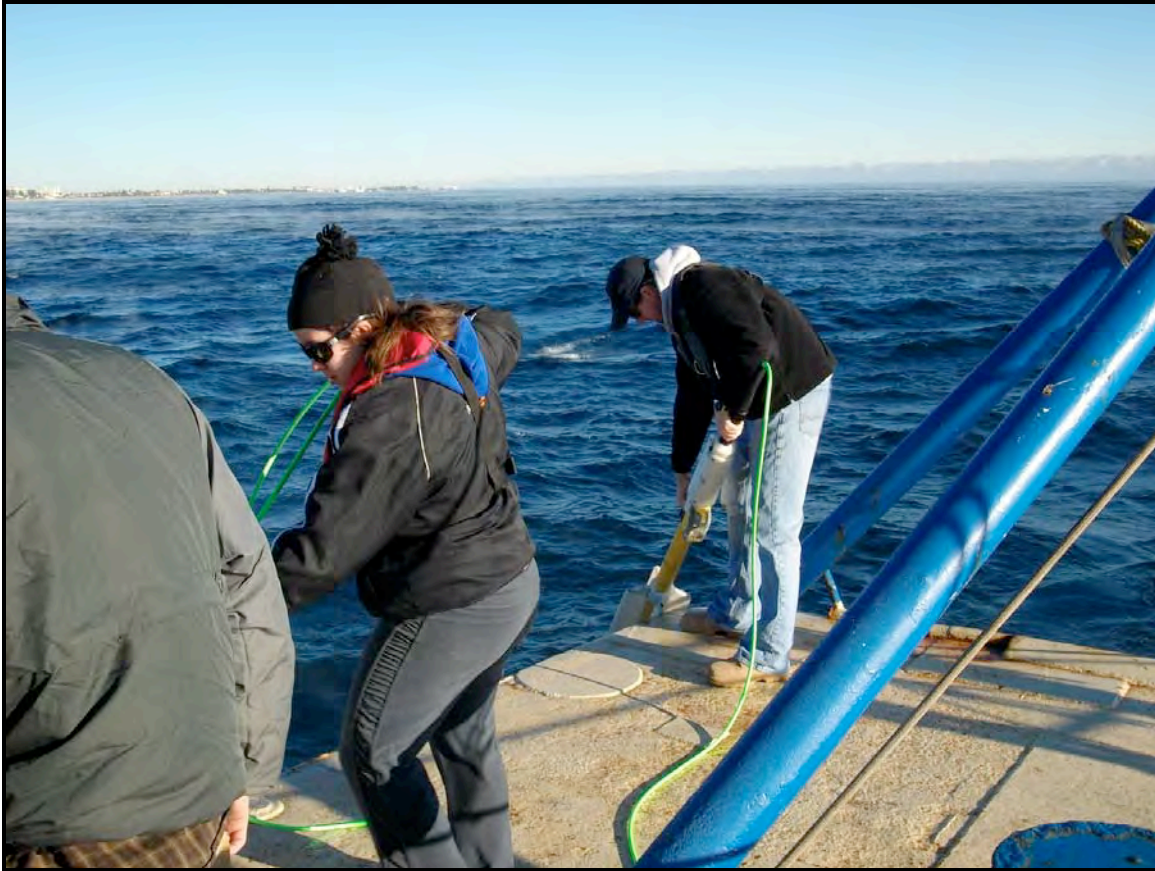
To identify anomalies associated with submerged cultural resources in the survey area, a Geometrics G-882 cesium-vapor marine magnetometer was employed to collect magnetic data in the survey areas. The Geometrics G-882 magnetometer is capable of plus or minus 0.001 gamma resolution (Figure 15). The cesium-vapor magnetometer provides a scalar measurement of the earth's magnetic field intensity expressed in gammas. Magnetic data were monitored on a chart as they were recorded as a HYPACK \*.RAW file on the navigation computer system.

**Figure 15. Geometrics G-882 magnetometer sensor.**

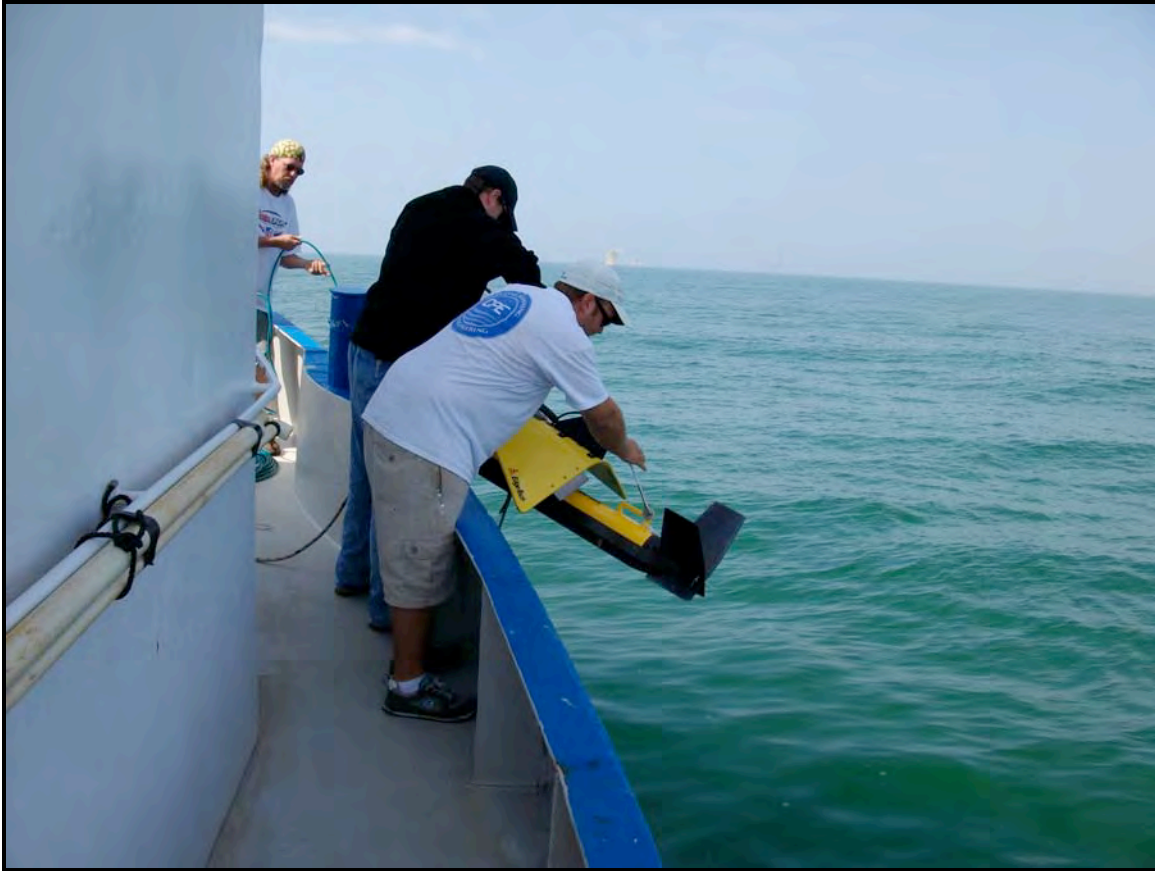
During the Dauphin Island survey, an EdgeTech 4200-HFL side scan sonar system was employed to collect acoustic data in the investigation area (Figure 16). The 4200-HFL uses full-spectrum CHIRP technology to deliver wideband, high-energy pulses coupled with high-resolution and superb signal to noise ratio echo data. The sonar package included a portable laptop configuration running DISCOVER acquisition software and a 300/600 kHz dual frequency, dual channel towfish running in high definition mode. Dual frequency provided a differential aid to interpretation. The side scan sonar transducer was deployed from the bow of the survey vessel and maintained between 8 and 10 feet below the water surface. Acoustic data were collected using a range scale of 246 feet (75 meters). The survey line spacing was designed to achieve total bottom coverage with

**Figure 16. Launching the EdgeTech 4200-HFL side scan sonar.**

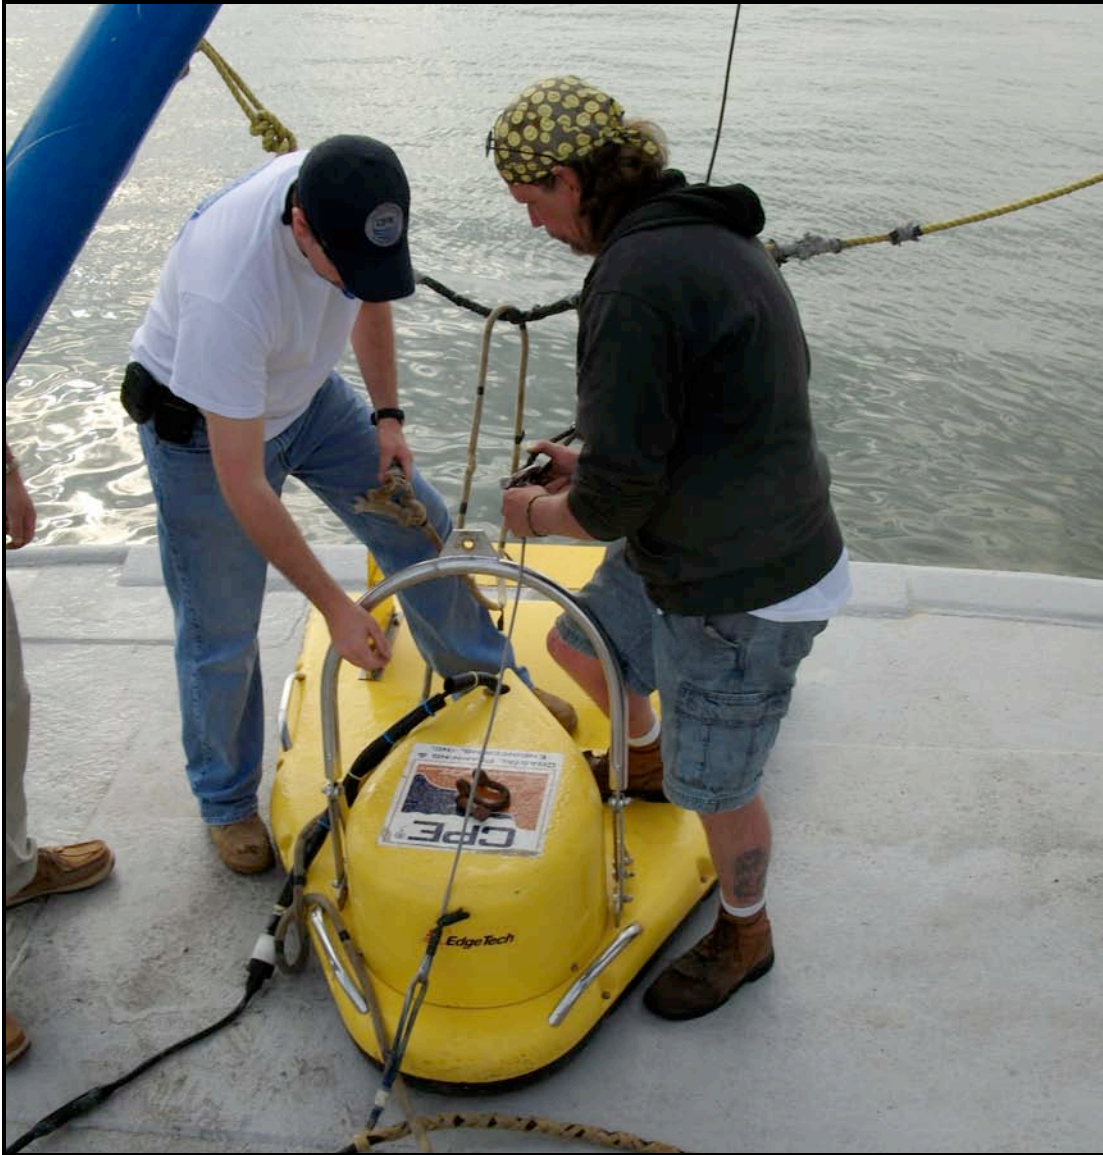
An EdgeTech 512i towfish (Figure 17) was employed with a Full Spectrum Sub-bottom Topside Unit to collect seismic data. The sub-bottom profiler sends an acoustic signal through the ocean bottom to record surface and subsurface geological features. Each distinct layer in the bottom sediment is indicated as a surficial trace, which is recorded in an electronic format onboard the survey vessel. The chart shows the presence of the sediment surface and other distinct layers or features within the sediment, such as buried river channels. The topside unit was utilized to control the 512i towfish and to display and archive the data, which was merged with positioning data via the computer navigation system and logged to disk for post-processing using EdgeTech's DISCOVER® software. The area was surveyed using the 0.7 KHz to 12 KHz 20ms FM pulse setting. The transducer was deployed between 8 and 12 feet below the water surface. The pulse repetition rate was typically twelve pulses per second.

**Figure 17. Launching the EdgeTech 512i Sub-bottom profiler.**

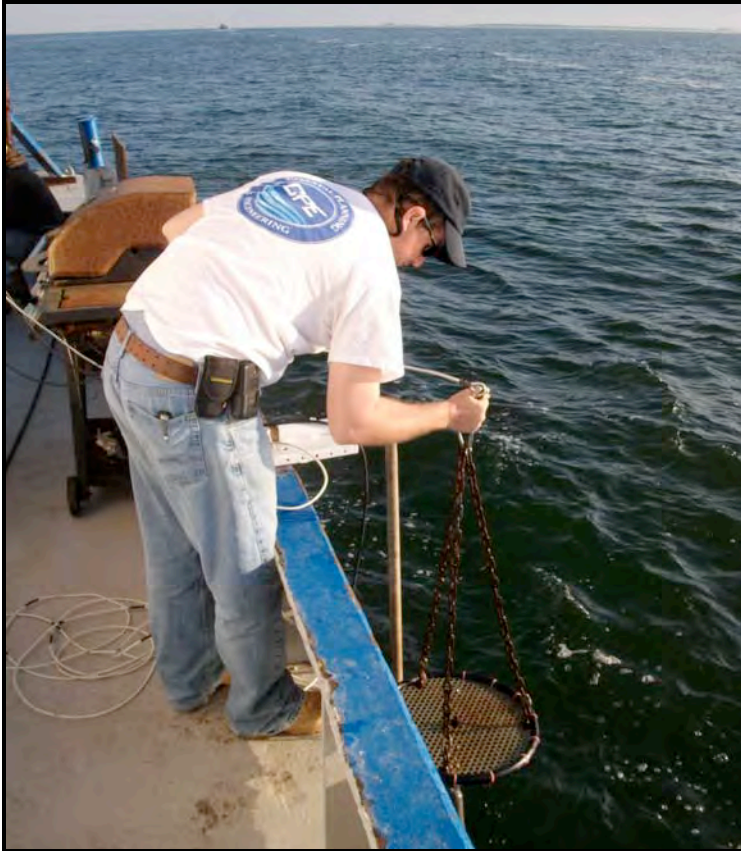
For the Dauphin Island project an Odom Hydrographic Systems Hydrotrac was used to perform the bathymetric survey. The Hydrotrac is a digital, survey-grade, single frequency portable hydrographic echo sounder which operates at frequencies of 24, 33, 40, 200, 210 or 340 kHz. A 210 kHz transducer was used for the bathymetric survey and was maintained at 2.9 feet below the water surface. Sounder calibration was performed twice daily via bar-checks and a sound velocity probe. A Digibar Pro sound velocity meter offered a quick, additional calibration for sound velocity as compared to the traditional bar-check. Bar-checks were also performed at 5-foot intervals (Figure 18). A TSS model DMS-25 Motion Compensator, interfaced to HYPACK, was used onboard the survey vessel to provide heave corrections. All bathymetric data were recorded in HYPACK as \*.RAW file on the navigation computer system at 10 samples per second.

**Figure 18. Preparing the bar check disk for deployment.**

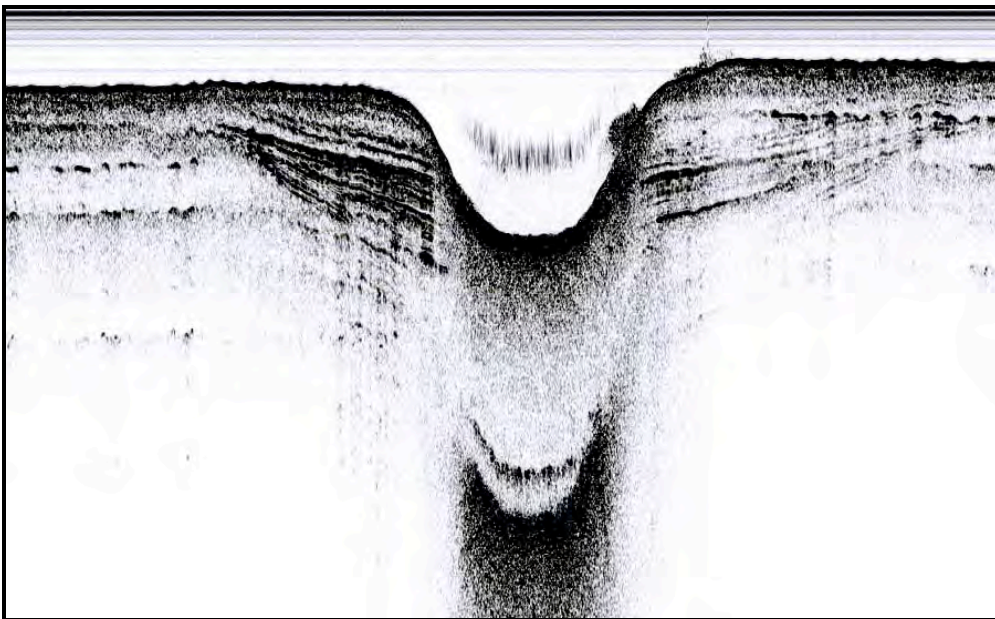
**Figure 25. Sub-bottom profile of a sink hole off Cape Romano, Collier County, Florida (Courtesy Coastal Planning and Engineering, Boca Raton, Florida).**

Although sub-bottom profilers have not generally produced a high degree of diagnostic insight into submerged cultural resources such as shipwrecks, the data they produce is extremely beneficial in locating, identifying and mapping relict landforms. Karst features like sink holes (Figure 25) and Paleo river channels (Figure 26) previously identified off Cape Romano, Florida provide excellent examples.

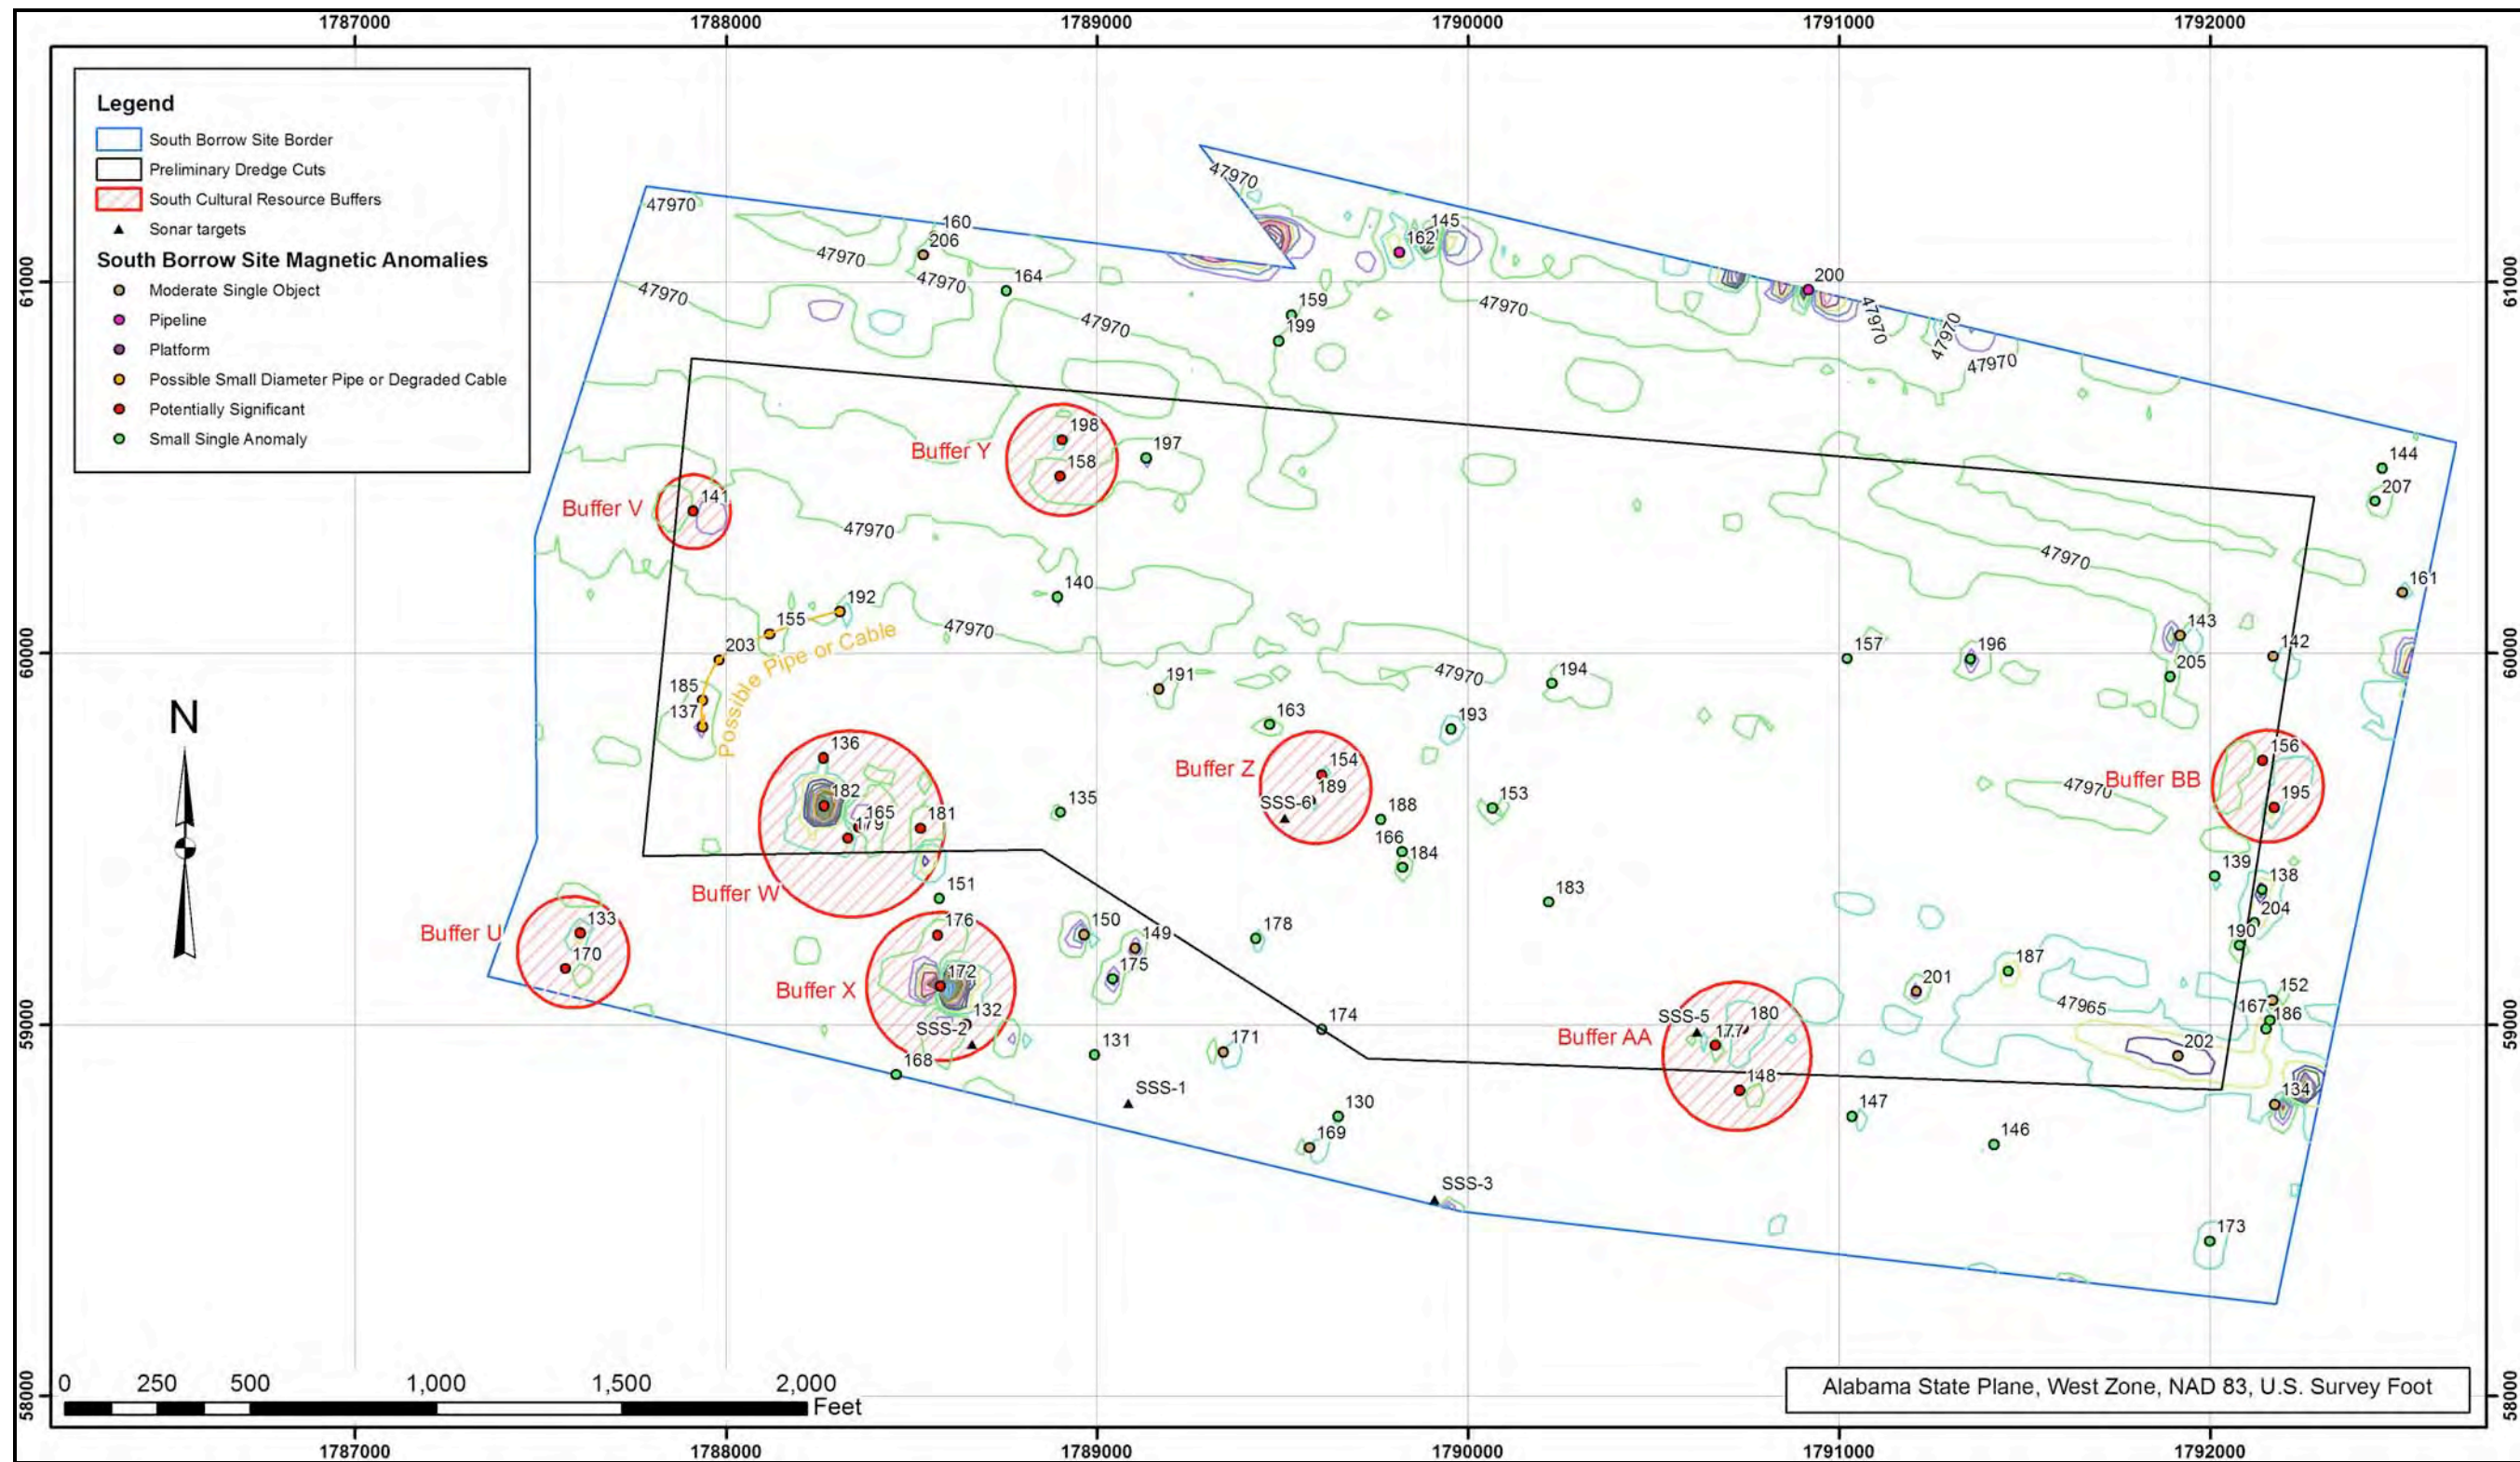
Figure 43. Magnetic contour map of the South Borrow Site investigation area with anomalies.

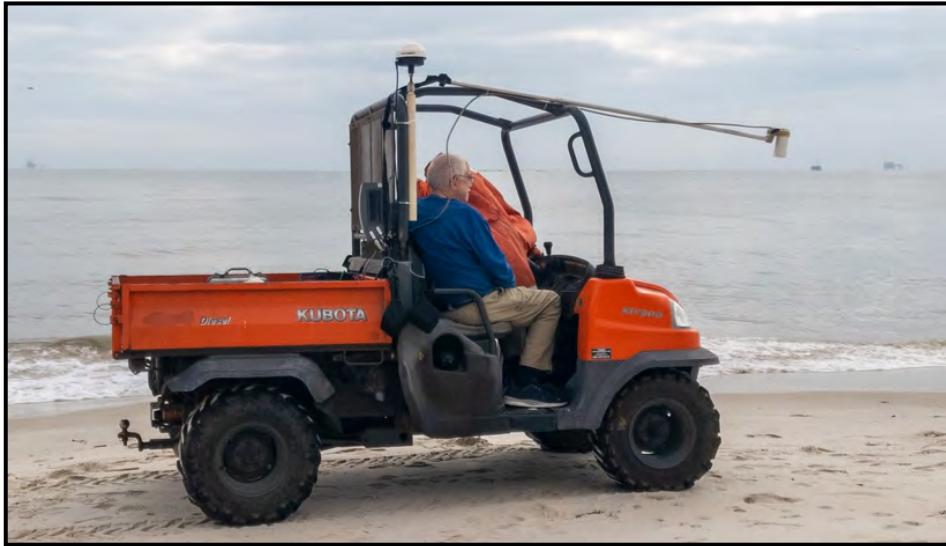
In order to identify cultural resources, TAR archaeologists conducted the remote-sensing survey of the Dauphin Island beach and dune restoration project site using a Kubota ATV (Figure 5). A Hemisphere DGPS and a Geometrics G-858 cesium vapor magnetometer were mounted on the Kubota.

**Figure 5. Kubota with mounted Hemisphere DGPS and G-858 magnetometer.**

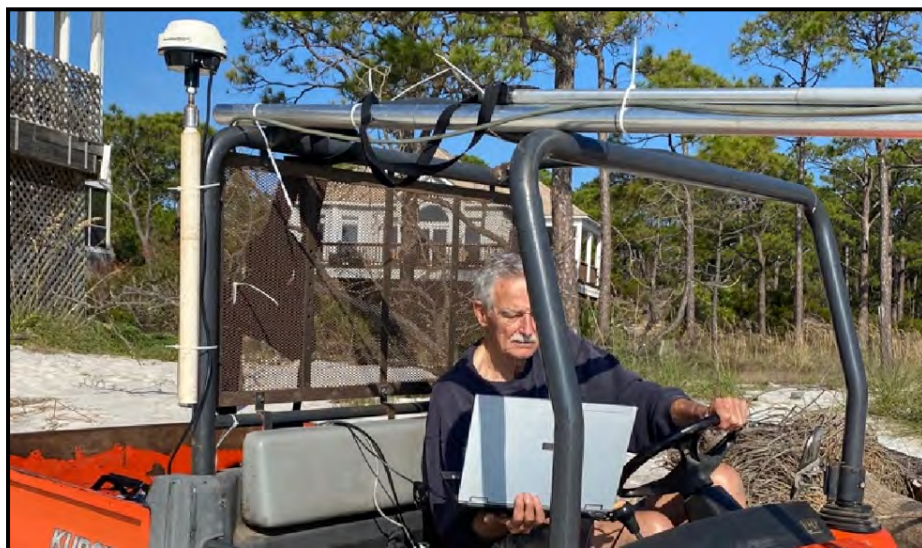
Data from the magnetometer and the DGPS were collected on a laptop using HYPACK survey software (Figure 6). Survey lines between the surviving dune vegetation and the Gulf of Mexico waterline were (where possible) investigated on a lane spacing of approximately 25 feet. Access to some areas of the dune restoration project site were restricted by vegetation debris and structures (Figure 7).

**Figure 6. Navigation and data collection were controlled by laptop.**

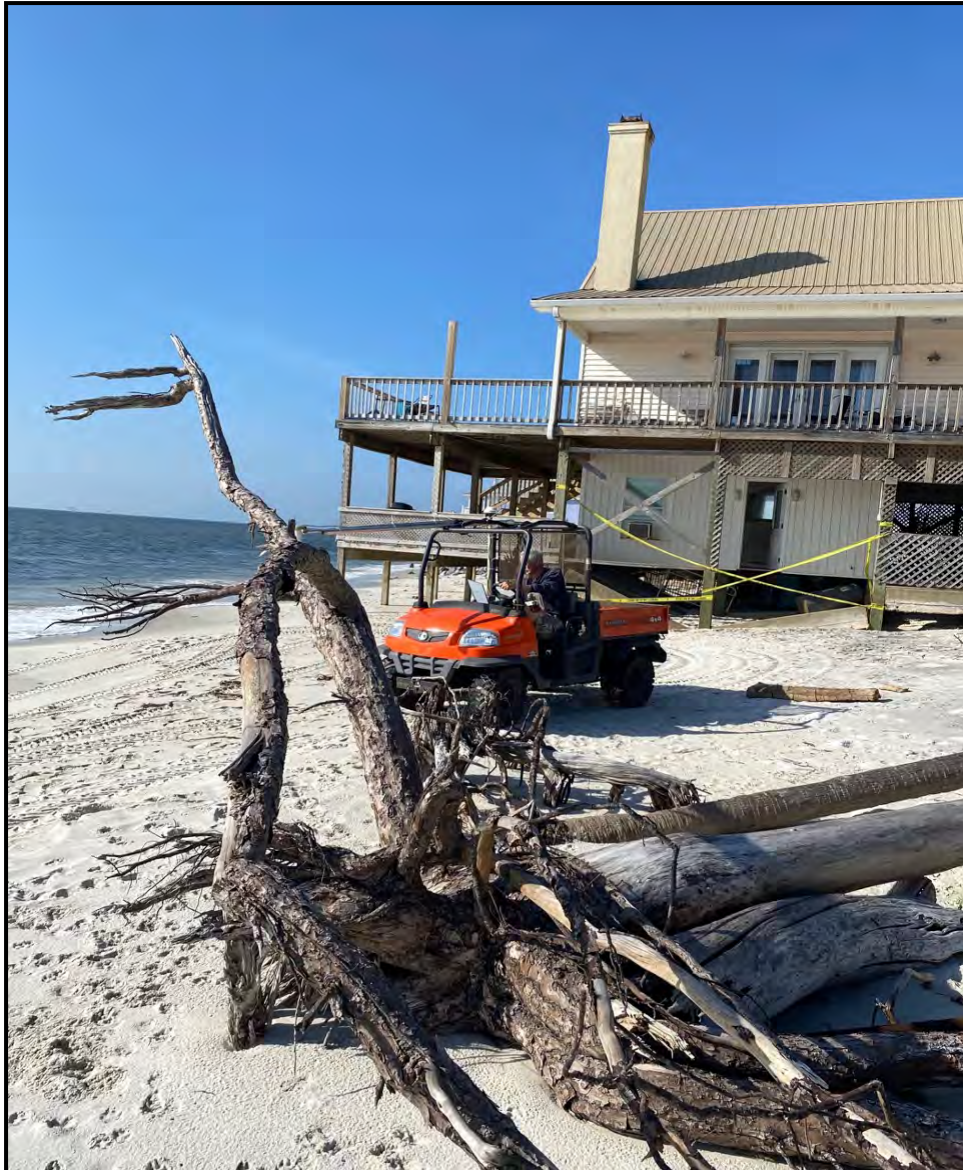
**Figure 7. Example of structures and vegetation debris in the study area.**

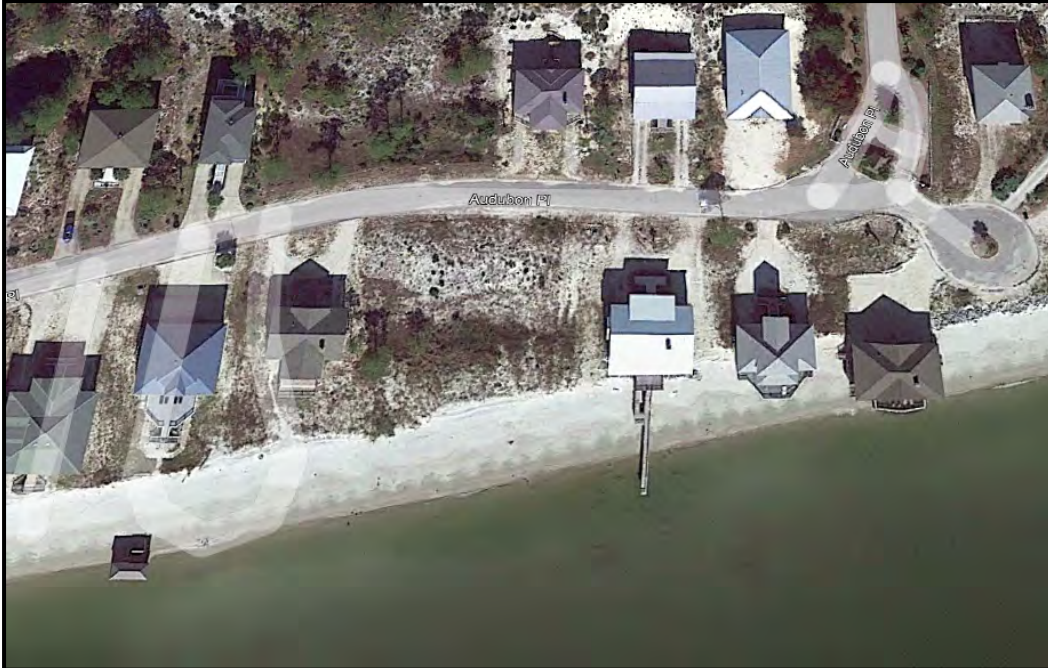
**Figure 8. Erosion threatened residential structures on Dauphin Island Beach in the study area (November 2019 Google Earth image).**

To ensure reliable target identification and assessment, preliminary analysis of the magnetic data was carried out as it was generated. Using HYPACK software, line-by-line analysis of the magnetic data was carried out to identify any anomalies. Any identified anomalies were isolated and analyzed in accordance with intensity, duration, areal extent and signature characteristics. Based on that analysis, no potentially significant magnetic signatures were identified. Anomalies in the survey area were determined to be associated with residential structures and associated modern debris (Figure 8) and features on the beach or in the adjacent shallow water that are associated with erosion control (Figure 9).

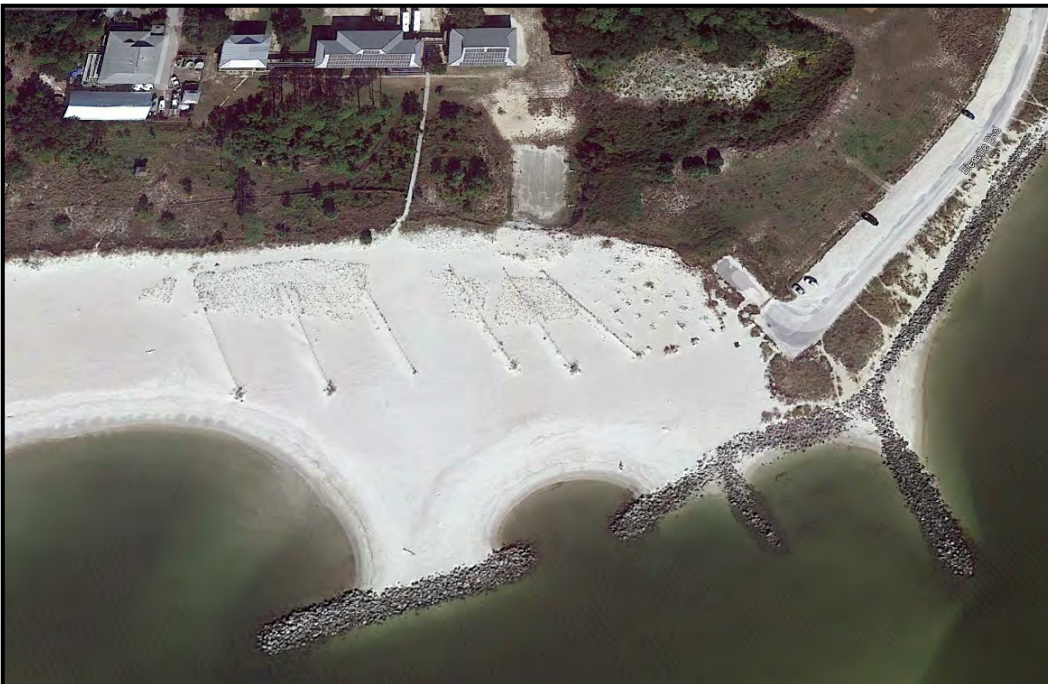
**Figure 9. Erosion control structures on south Pelican Point beach in the study area (November 2019 Google Earth image).**
